**C-130 Broad Area Review (BAR)**

**ADDENDUM**

**King 56 Salvage**

25 August 1998 Addendum  
to the 15 January 1998 Report

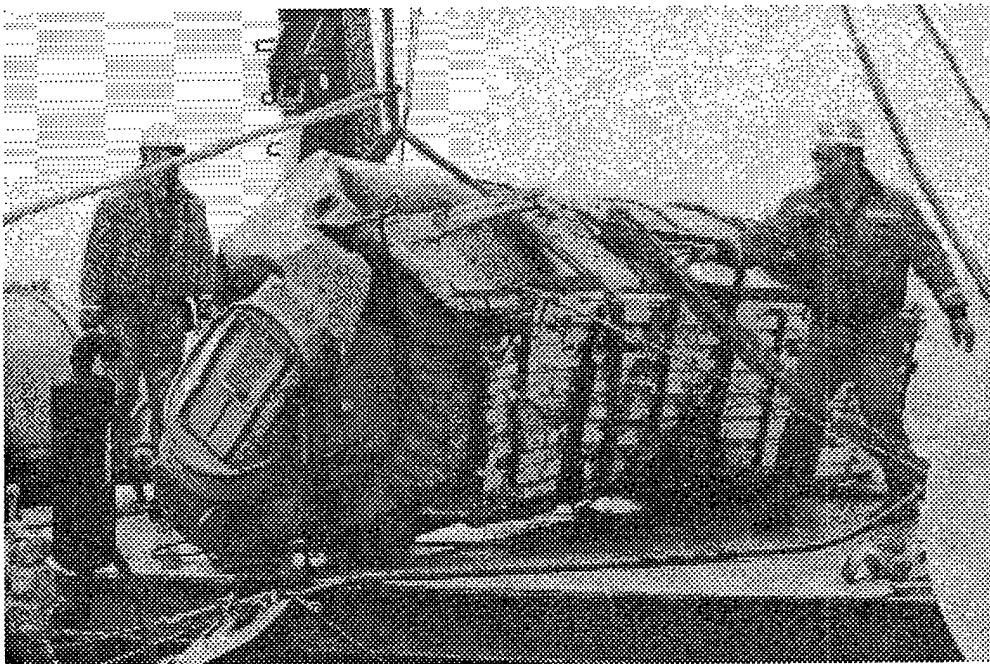
**2.2.4.2 Right Fuselage Tank – External & Internal Inspection.** All the fuel foam in the right fuselage tank was removed to facilitate an internal inspection. Samples of the charcoal-colored foam from this tank was removed and visually examined. In addition, these samples were sent to ASC/ENF for further examination. Nothing unusual was noted. The inside of the tank was fully inspected for the presence of foreign objects and anything else unusual (i.e., extra parts, lost tools, missing parts, excessive corrosion, improperly installed parts, etc.). The fuel supply lines, that is the lines and check valves from the pumps to the top of the tank, were found to be properly installed and unobstructed. All three check valves in this fuel supply manifold were installed properly and their flappers operated easily. The supply and return lines for the ejector pump were installed correctly. The check valve in the ejector pump pick-up line was installed correctly and its flapper operated easily. Neither the supply line, return line, nor the pick-up line for the ejector pump were obstructed. The only thing unusual noted in this tank was the presence of the gravity fill tube below the gravity fill port and the presence of the impingement cage around the refuel

valve. The presence of these items would not adversely affect tank performance, but their presence is unusual since these items should have been removed in 1990 via TCTO 1C-130-1329. Nothing else unusual was noted.

RT Fuselage Tank on Deck of M/V Independence

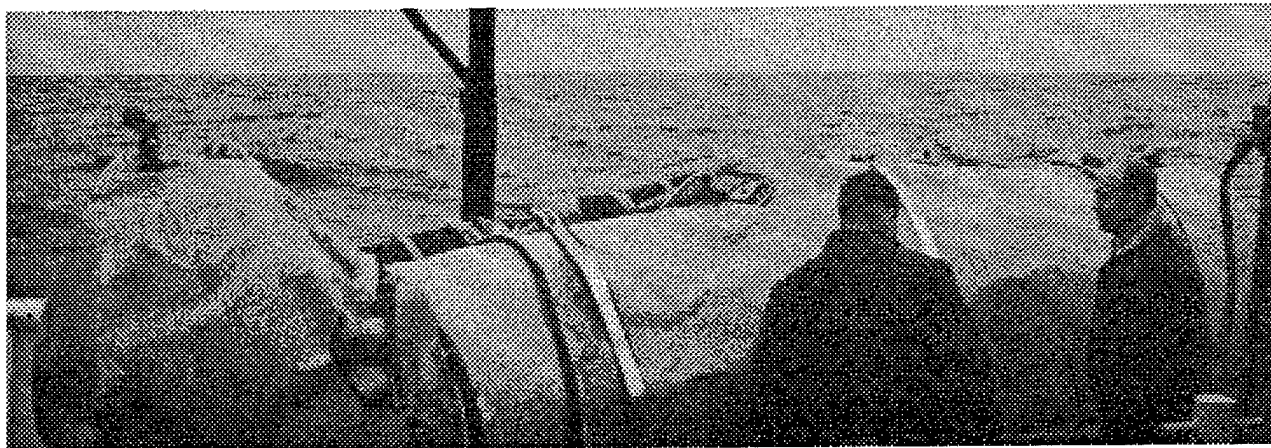
**2.2.5.2 Left Fuselage Tank – External & Internal Inspection.** All the fuel foam in the left fuselage tank was removed to facilitate an internal inspection. Samples of the charcoal-colored fuel foam from this tank were removed and visually examined. In addition, these samples were sent to ASC/ENF for further examination. Nothing unusual was noted. The inside of the tank

was fully inspected for the presence of foreign objects and anything else unusual (i.e., extra parts, lost tools, missing parts, excessive corrosion, improperly installed parts, etc.). The fuel supply lines, that is the lines and check valves from the pumps to the top of the tank, were found to be properly installed and unobstructed. All three check valves in this fuel supply manifold were installed properly and their flappers operated easily. The supply line to the ejector pump was installed correctly except for one loose (i.e., finger tight) B-nut. The return line from the ejector pump was installed correctly. The check valve in the ejector pump pick-up line was installed correctly and its flapper operated easily. Neither the supply line, the return line, nor the pick-up line for the ejector pump were obstructed. However, two unattached metal plates (P/Ns 8614271-14) were found near the inlet for the ejector pump pick-up line. The tank's fuel foam trapped the plates against the tank wall where they were rendered harmless. Nothing else unusual was noted.

LT Fuselage Tank on Deck of M/V Independence

**RECOMMENDATION:** WR-ALC/LB direct a one-time inspection of all fuselage tanks to ensure proper completion of TCTOs and check for corrosion and presence of foreign objects.

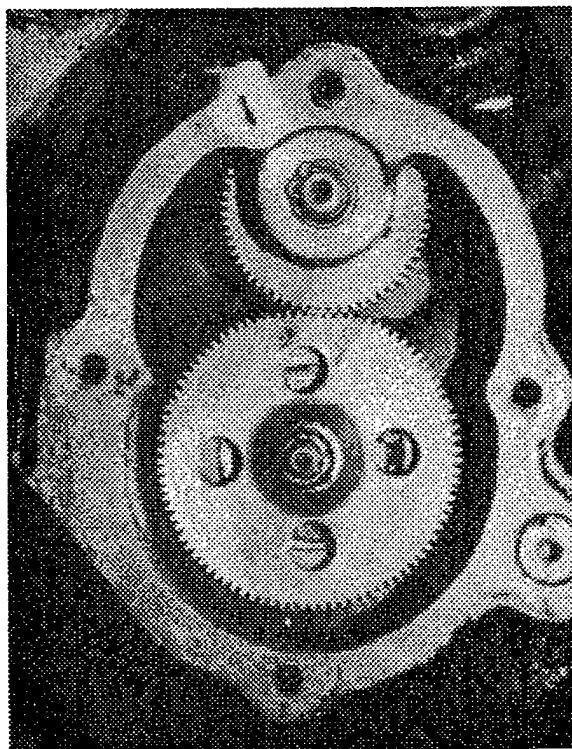
**TD VALVE TEARDOWN & INSPECTION:** Numerous safety seals were missing due to corrosion. The metering valve train appeared to be functioning correctly. Fuel Accessory shop

technicians verified the proper alignment of the metering valve drive gears from previous overhaul marks on these gears. The gears indicated that the TD Valve was in a "put" condition at the time electrical power was lost. The remainder of the TD Valve was disassembled and inspected for abnormalities. None were noted.

TD Valve from #1 Engine, in a slight "PUT" Position

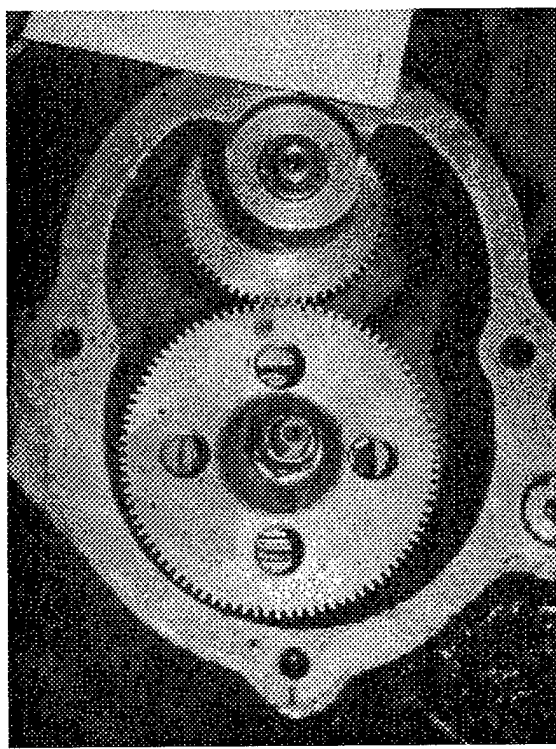
TD Valve #1 with the Motor Removed and now in  
NULL

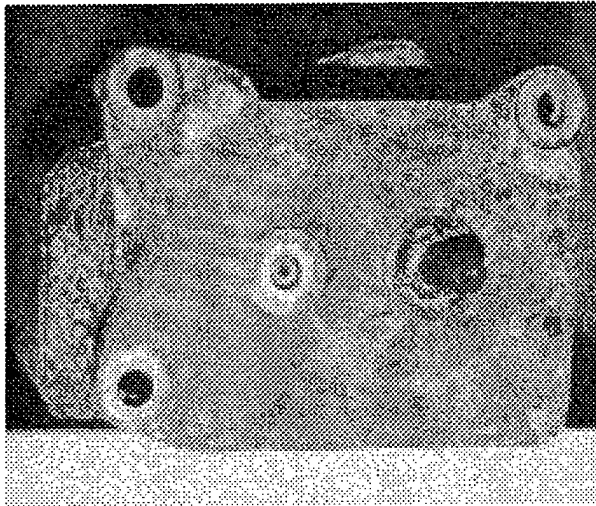
*Fuel Shutoff Valve Motor #1 in "close" Position*

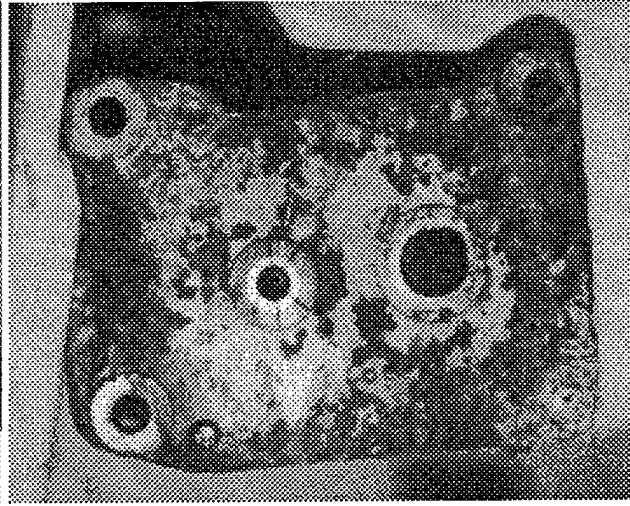
*Fuel Shutoff Valve Motor #3 in "open" Position*

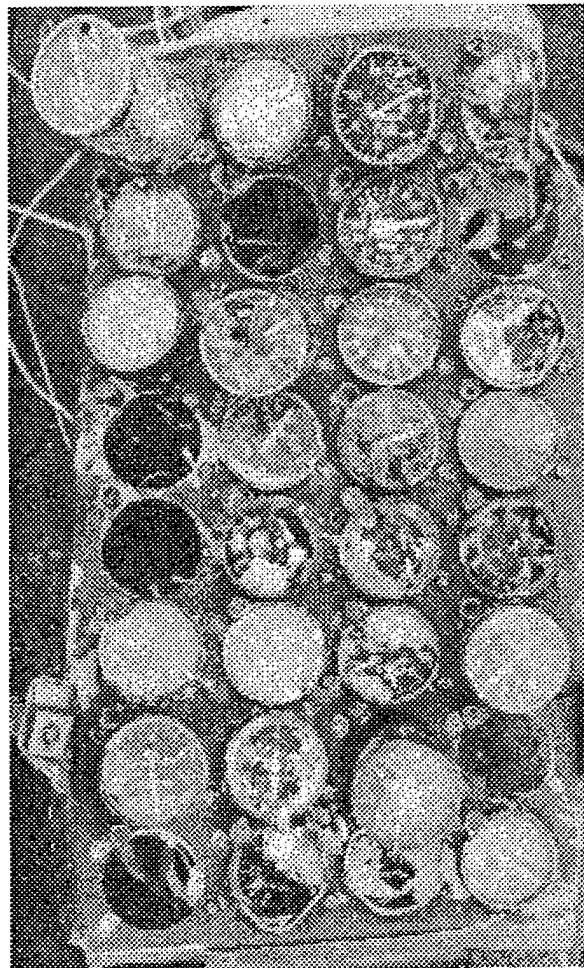
*Engine Instrument Panel*

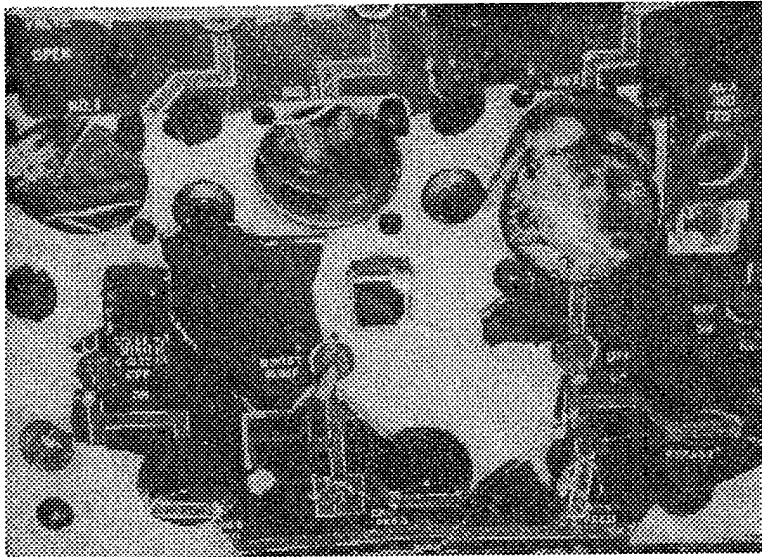
*Fuel Management Panel (Left Side)*

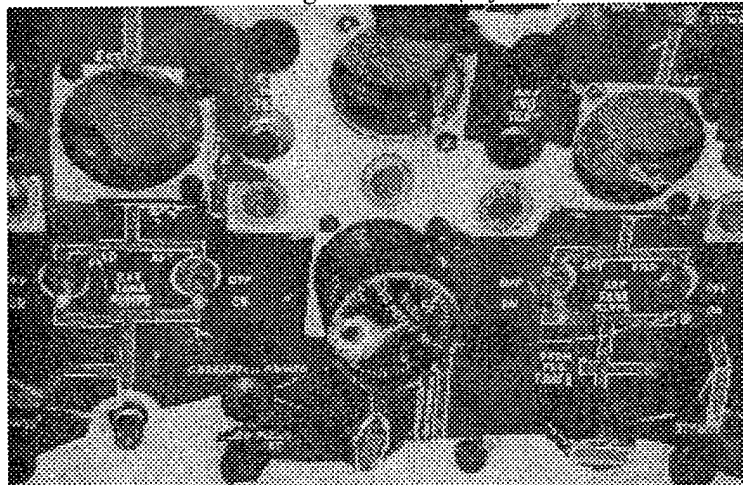
*Fuel Management Panel (Middle)*

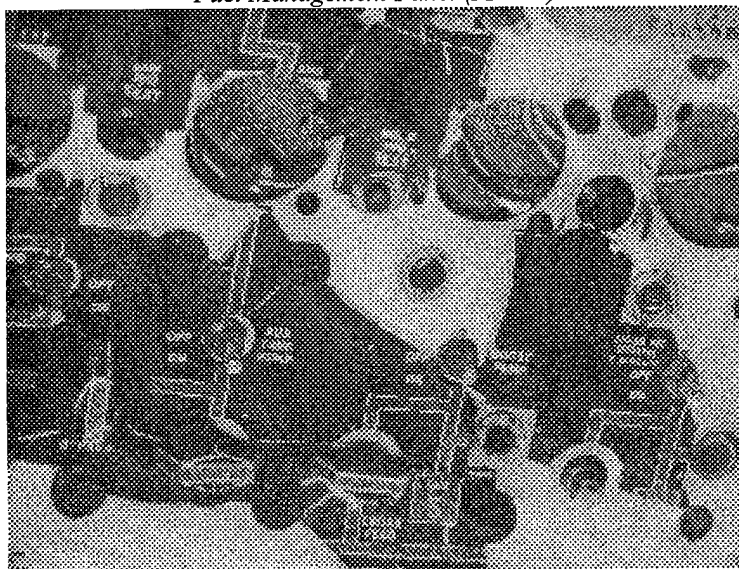
*Fuel Management Panel (Right Side)*

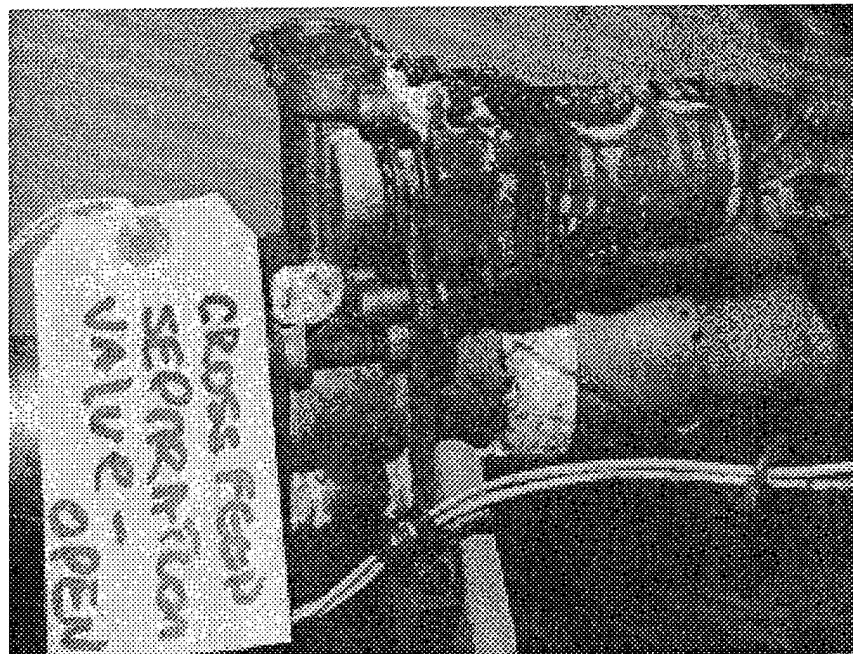
*Crossfeed Separation Valve - Found Open*

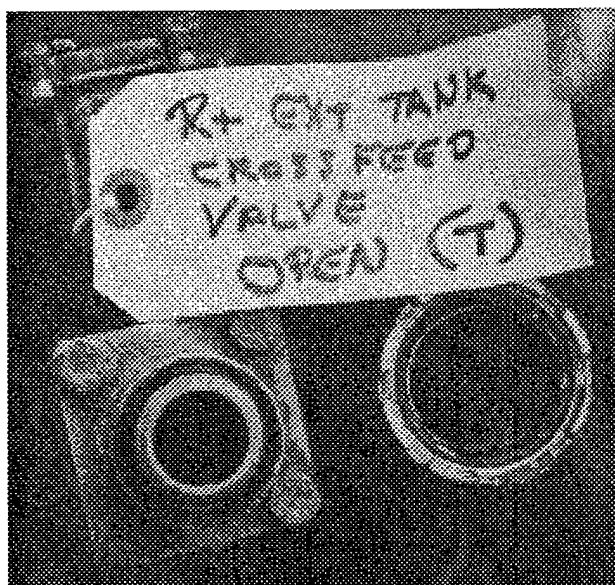
*Right External Crossfeed Valve - Found Open*

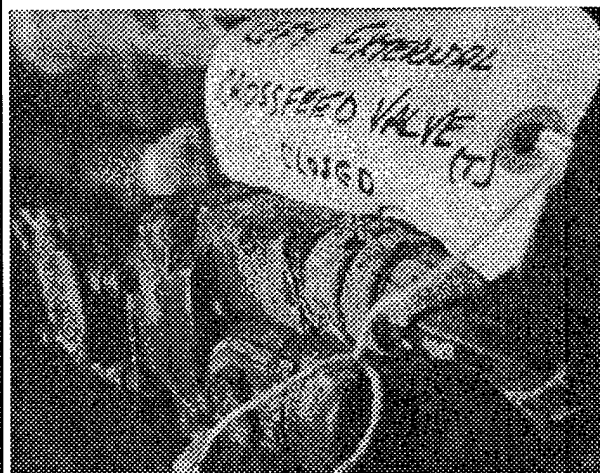
*Left External Crossfeed Valve - Found Closed*

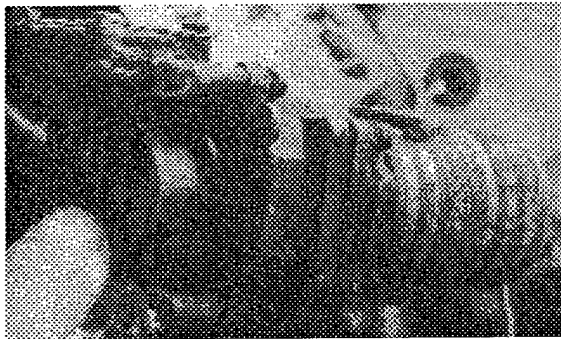
**Right Auxiliary Crossfeed Valve – Found Closed**

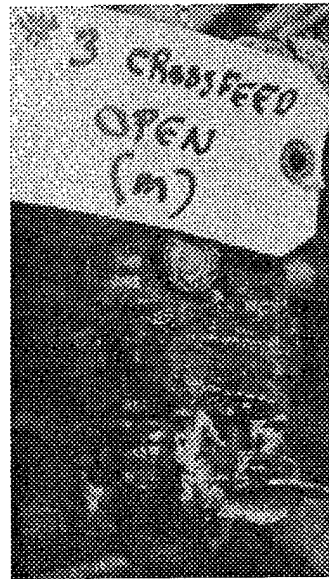
**#3 Crossfeed Valve – Found Open**

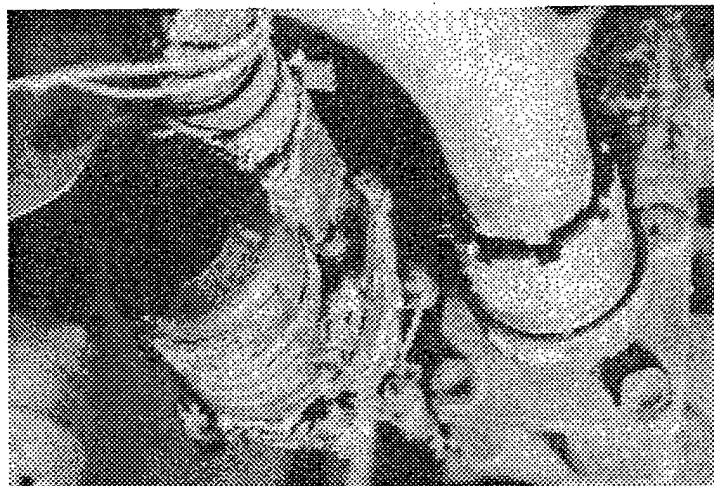
*Left Auxiliary Crossfeed Valve – Found Closed*
